ARMY ENGINEER WATERWAYS EXPERIMENT STATION VICKSBURG--ETC F/6 20/4
SPILLWAY FOR COOPER DAM, SULPHUR RIVER, TEXAS. HYDRAULIC MODEL --ETC(U)
AUG 80 J F GEORGE
WES/TR/HL-80-15

1. REPORT NUMBER Technical Report HL-86-15 ✓	2. GOVT ACCESSION NO. AD-A094 237	3. RECIPIENT'S CATALOG NUMBER
4. TITLE (and Subtitle) SPILLWAY FOR COOPER DAM, SULPHUR RIVER, TEXAS Hydraulic Model Investigation,		5. TYPE OF REPORT & PERIOD COVERED Final report.

SPILLWAY FOR COOPER DAM, SULPHUR RIVER, TEXAS

Hydraulic Model Investigation

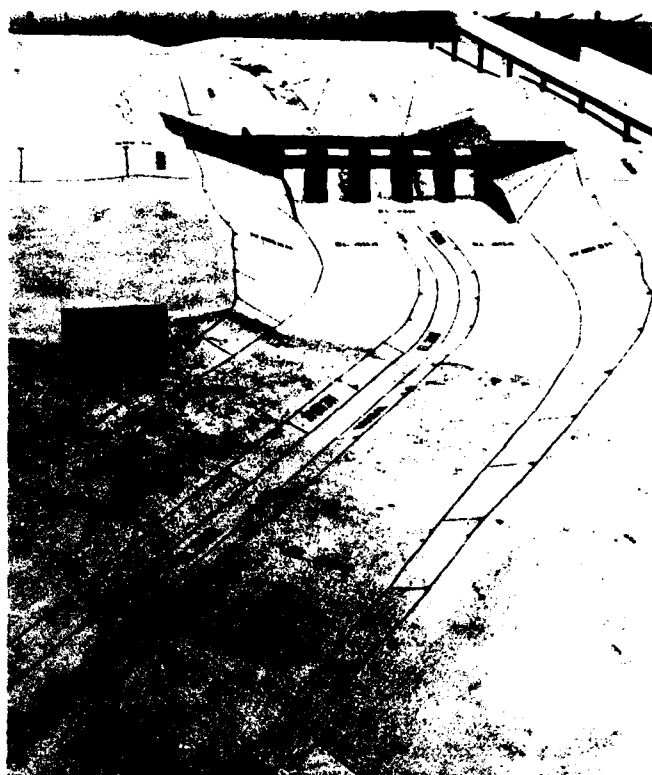
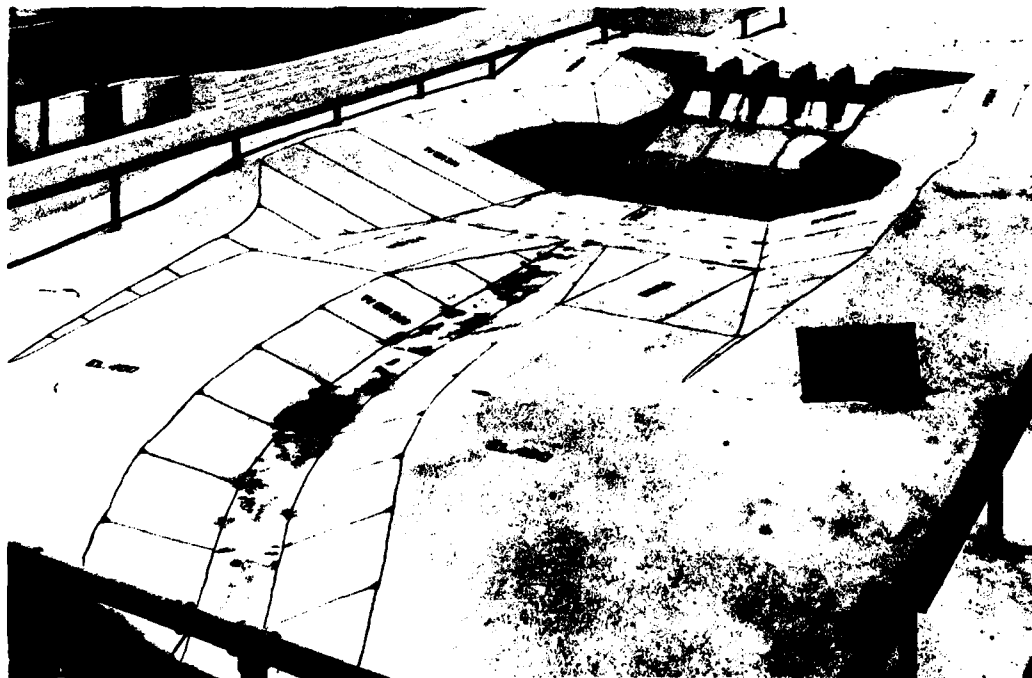
Figure 2. General view of model

a. Looking downstream

b. Looking upstream

8. The 1:36-scale model reproduced approximately a 1,300-ft-long approach area, the entire service spillway including nonoverflow sections, and 800 ft of exit channel (Figure 2). The proposed spillway and tainter gates were constructed of sheet metal, and all piers and vertical slide gates were constructed of transparent plastic. The stilling basin, baffle blocks, end sill, and stilling basin walls were constructed of plastic-coated plywood. The approach channel, nonoverflow sections, and exit channel were molded in sand and cement mortar to sheet-metal templates initially to observe the performance of the spillway with various flow conditions. The cement mortar was replaced with riprap in later tests to determine the optimum channel protection downstream of the structure. Filter cloth was placed between the sand and graded riprap for all channel protection tests.

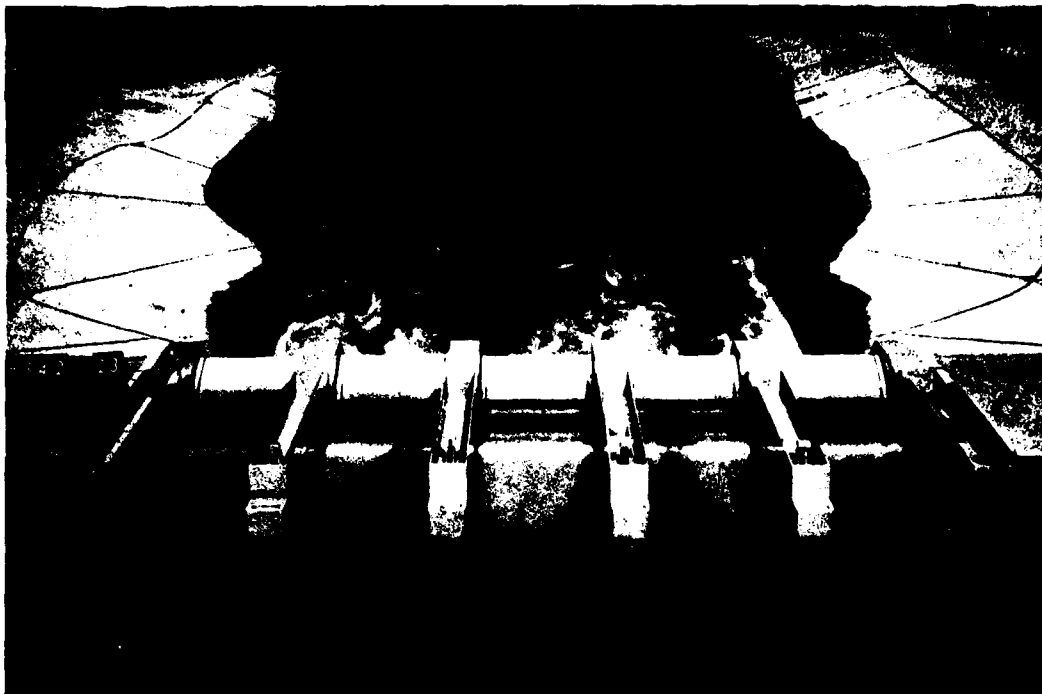
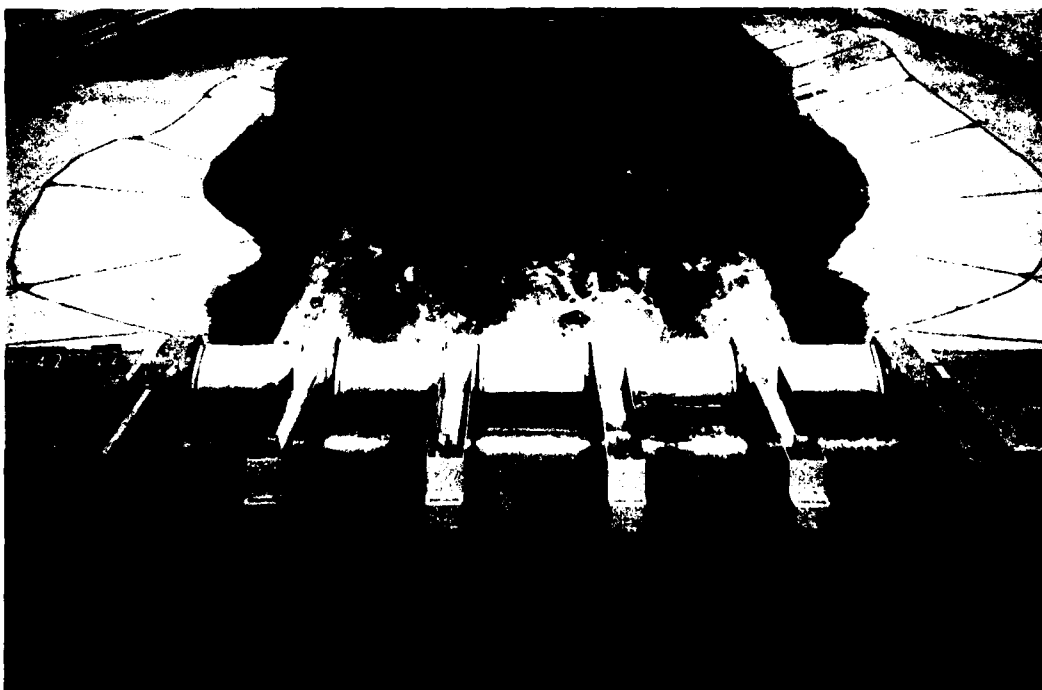
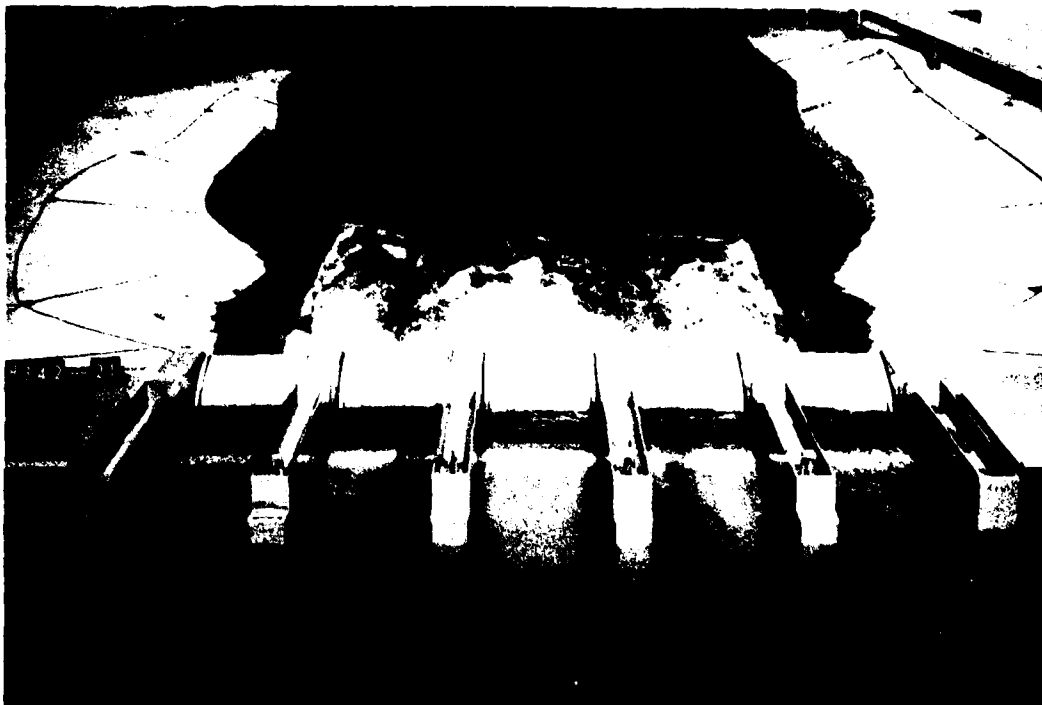
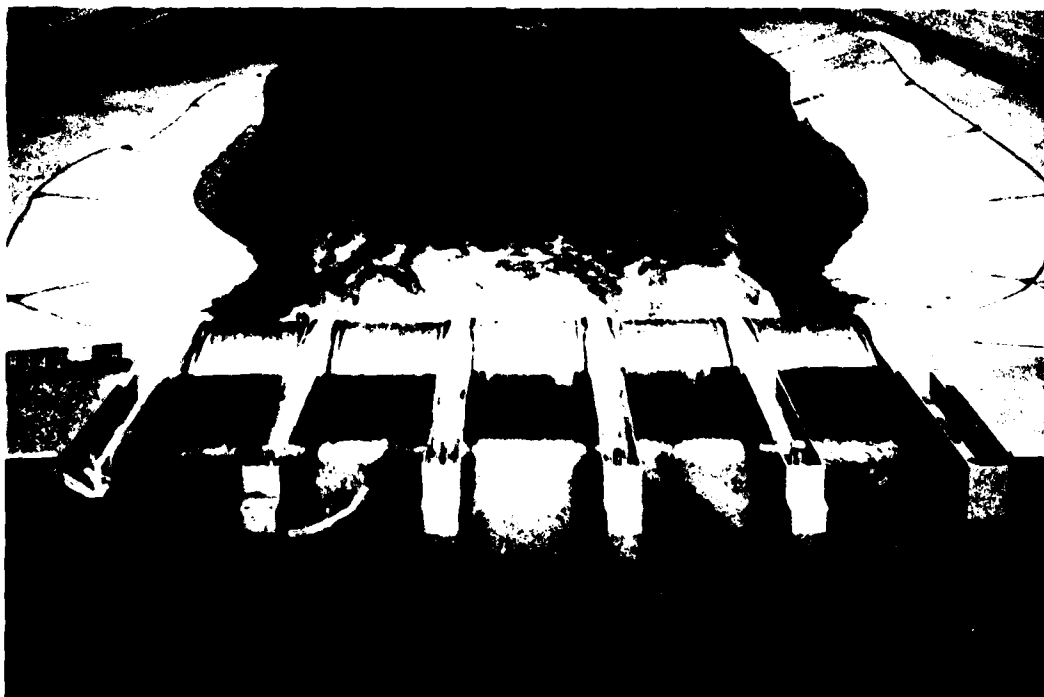
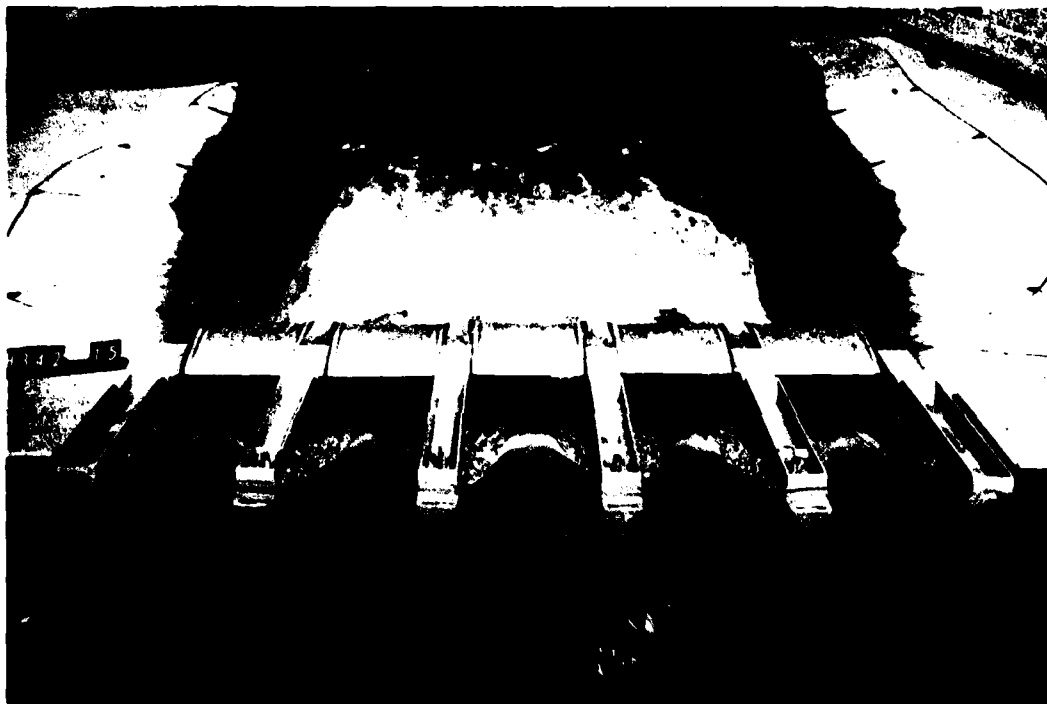
Photo 1. Looking downstream at flow conditions immediately upstream of spillway; upper pool el 440.0 (Sheet 1 of 3)

a. Gate opening 4 ft, discharge 16,000 cfs, tailwater el 402.0

b. Gate opening 6 ft, discharge 23,000 cfs, tailwater el 403.5

c. Gate opening 8 ft, discharge 30,000 cfs, tailwater el 404.5

d. All gates fully open, discharge 40,000 cfs, tailwater el 406.0

e. All gates fully open, discharge 110,000 cfs, tailwater el 410.5

18. With the design discharge of 110,000 cfs, cross waves were created by the piers in each gate bay (Photo 1). The cross waves were confined to the surface since uniform velocity distributions were observed throughout the depth of flow at the crest and in the stilling

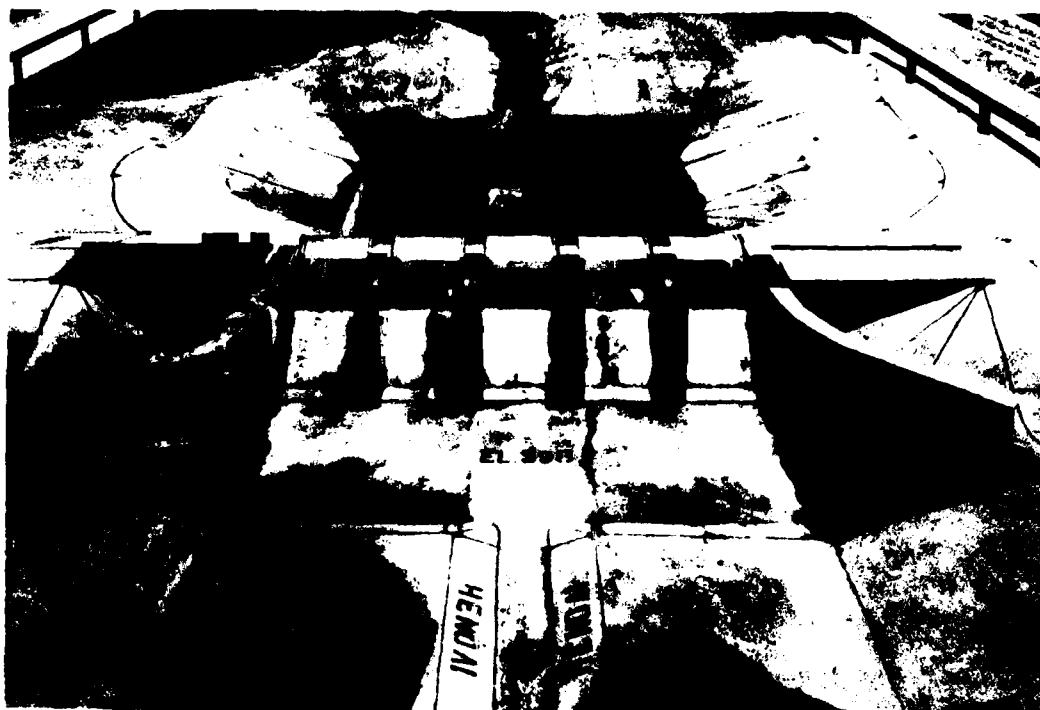
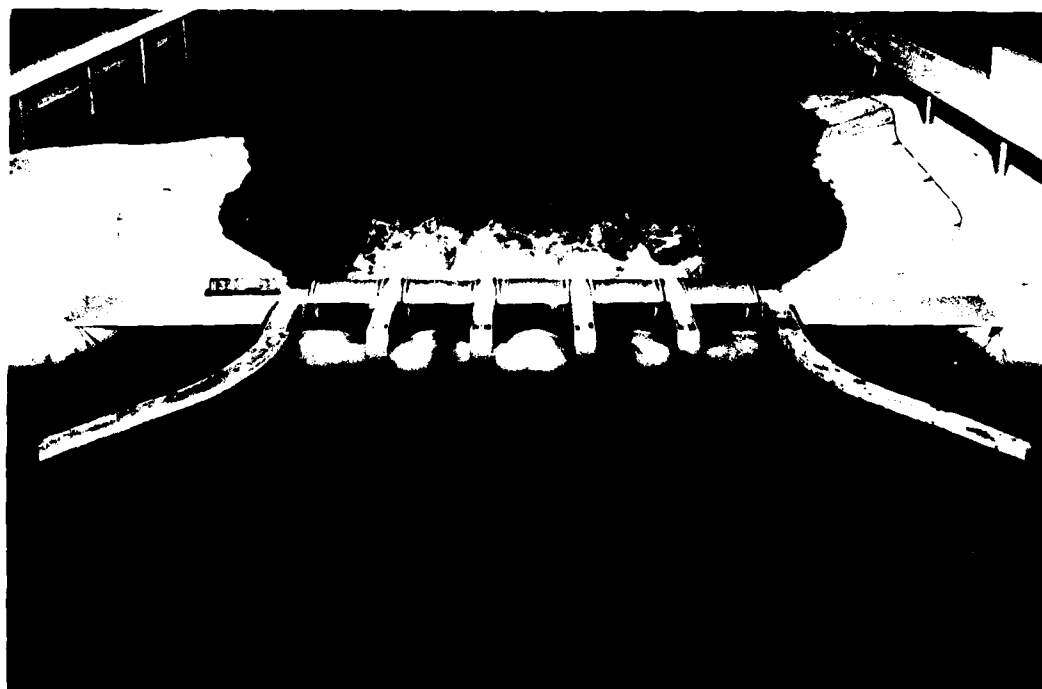
Photo 2. Type 3 approach wing wall

a. Dry bed

b. All gates fully open, discharge 110,000 cfs, upper pool el 452.3

16. The type 3 approach wing wall design reduced the buildup of the water surface along the left and right walls of the spillway more effectively than the other designs tested. However, little improvement was obtained in the velocity distribution relative to the other designs tested. Also, little change was observed in the discharge calibration data obtained with the type 3 design as compared with the first two approach wing wall designs tested (Plate 7). The expense of the additional wall height is probably not justifiable since the only benefit derived from this design was a reduction in the water surface along the sides of the spillway. Therefore, the original design (type 1) approach wing walls were reinstalled.

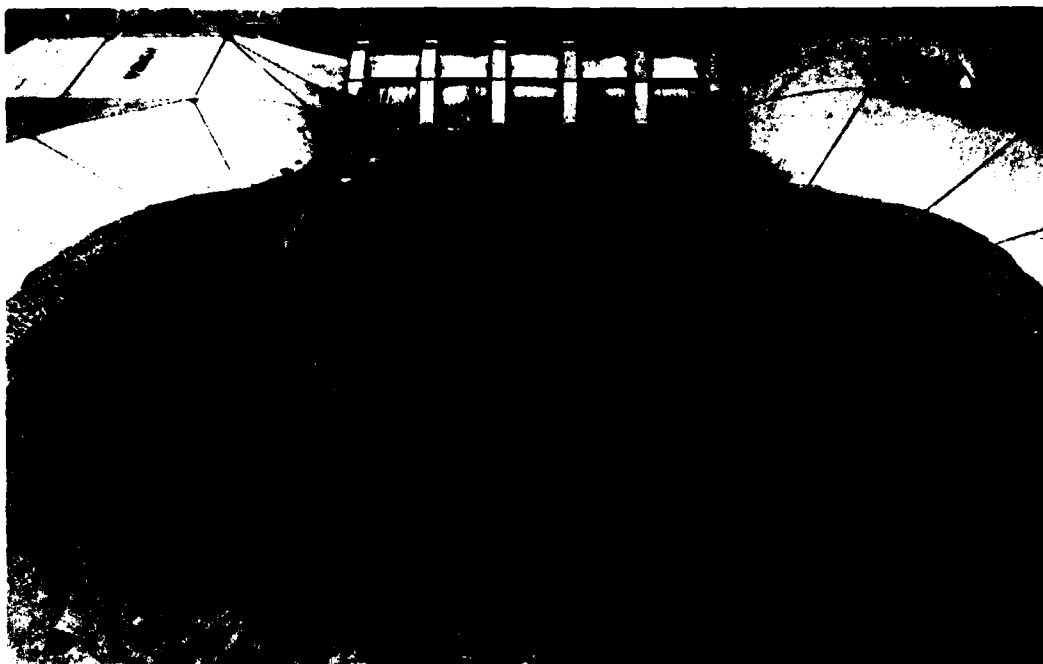
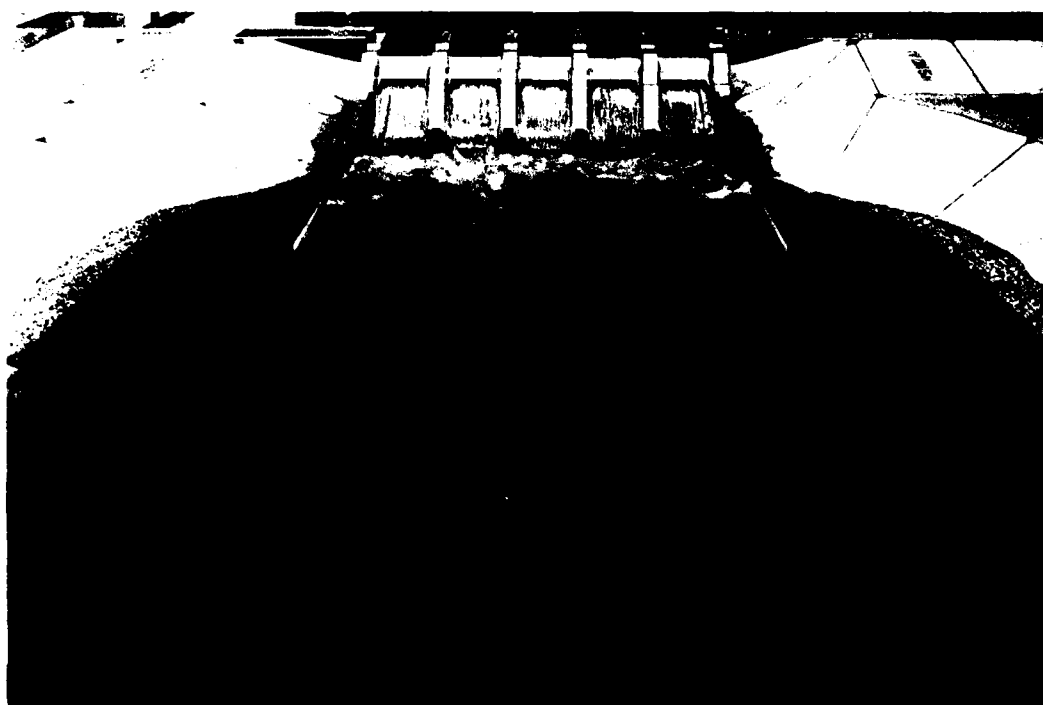
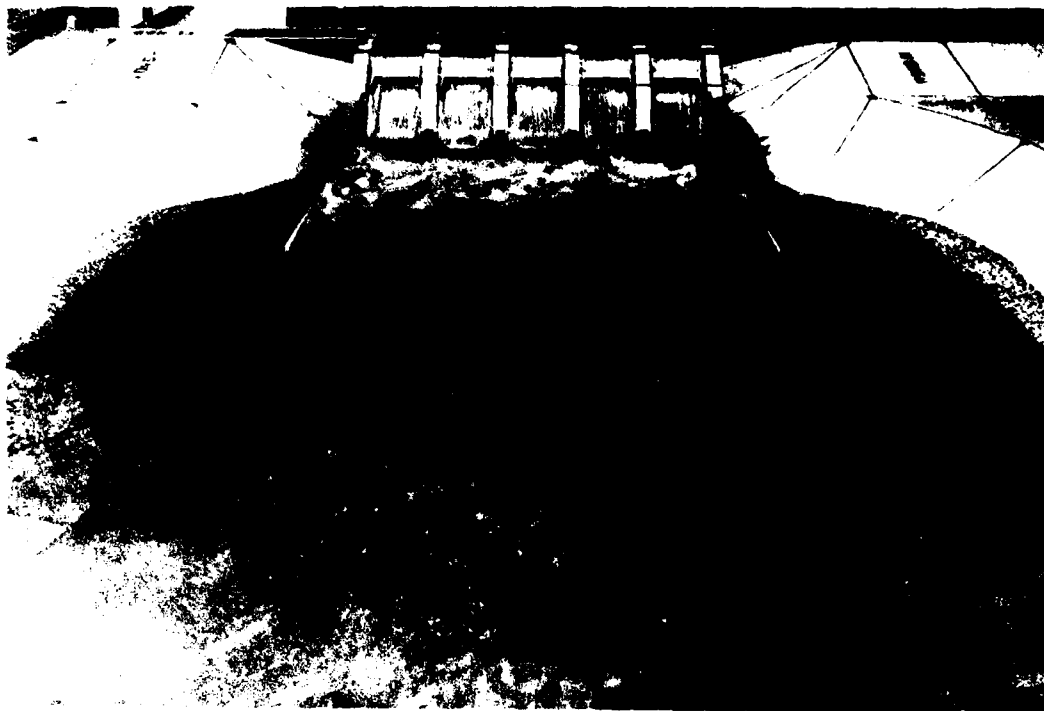
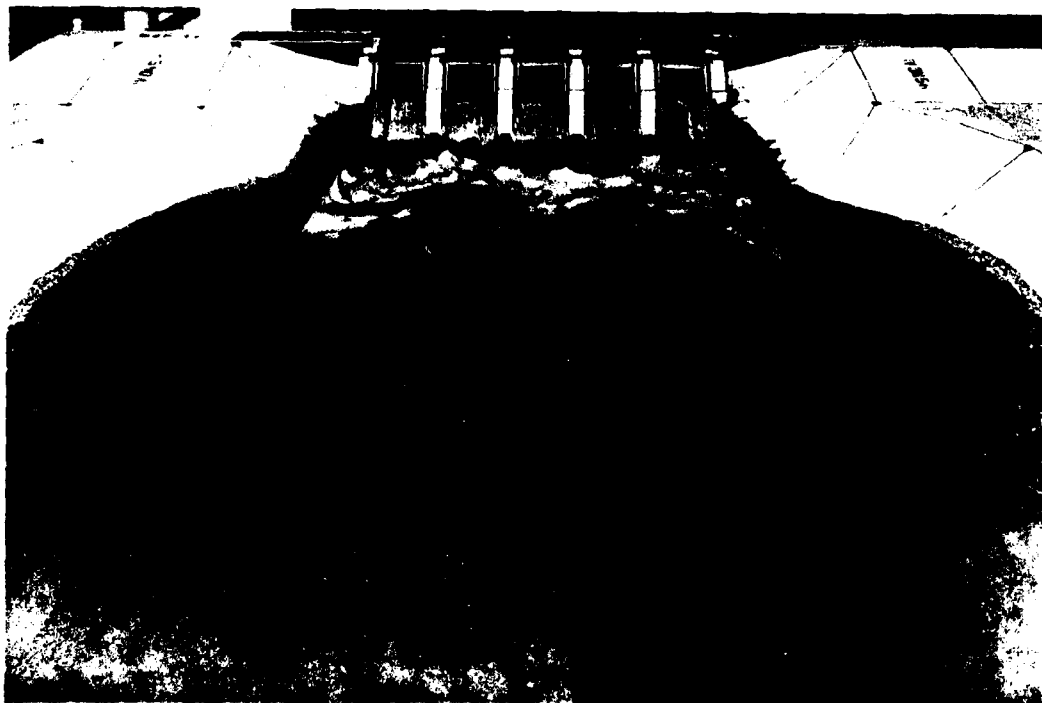
Photo 3. Looking upstream at flow conditions in the type 1 stilling basin; discharges 16,000, 23,000, 30,000, and 40,000 cfs; upper pool el 440.0 (Sheet 1 of 2)

a. Gate opening 4 ft, discharge 16,000 cfs, tailwater el 402.0

b. Gate opening 6 ft, discharge 23,000 cfs, tailwater el 403.5

c. Gate opening 8 ft, discharge 30,000 cfs, tailwater el 404.5

d. All gates fully open, discharge 40,000 cfs, tailwater el 406.0

17. Performance of the spillway and stilling basin was observed and documented with discharges ranging from 8,000 cfs to 110,000 cfs and various upper pool and tailwater elevations. At the normal upper pool elevation of 440.0, flow conditions were satisfactory throughout the spillway and stilling basin for the majority of gate openings and tailwater elevations observed. Velocities measured on the spillway crest and at several locations in the stilling basin with a discharge of 40,000 cfs, the normal upper pool elevation, and all gates fully open indicated uniform velocity distribution throughout the structure as shown in Plate 8. Various flow conditions with normal upper pool are shown in Photo 3.

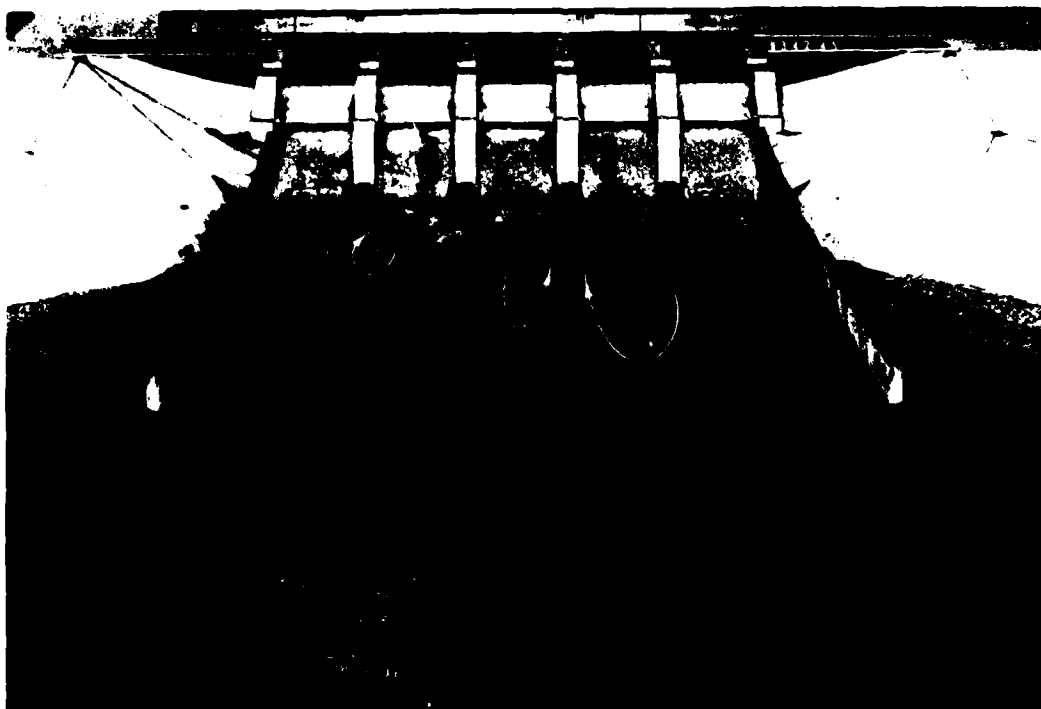
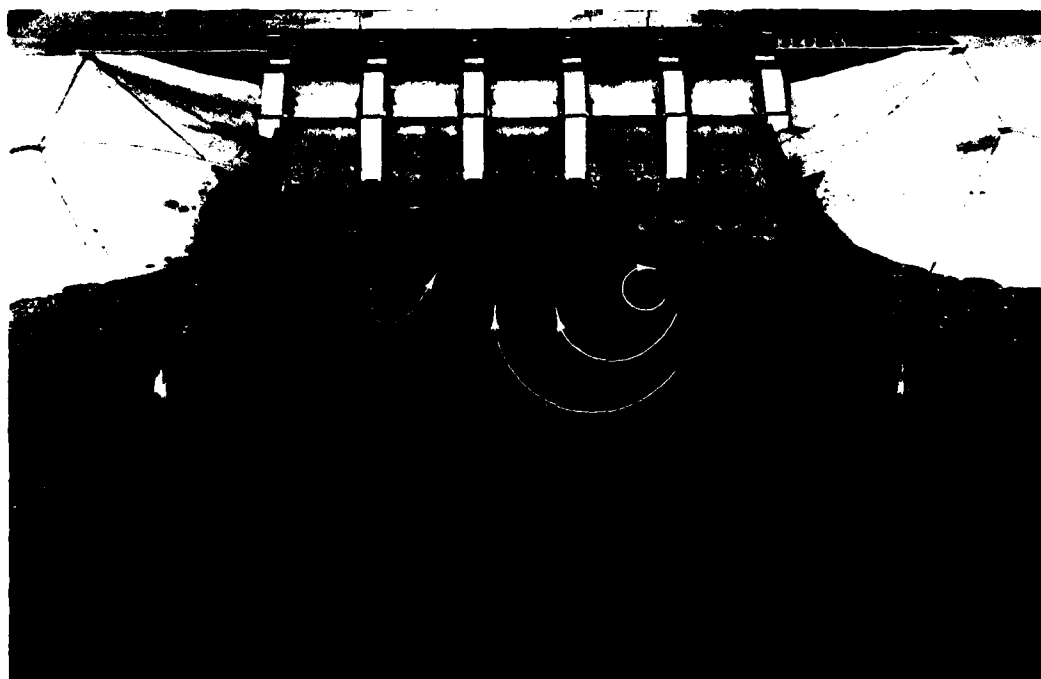
a. Gate opening 1 ft, discharge 6,000 cfs, tailwater el 399.2

b. Gate opening 2 ft, discharge 10,000 cfs, tailwater el 400.5

Photo 5. Looking upstream at flow conditions in the type 1 stilling basin; discharges 6,000 and 10,000 cfs; upper pool el 440.0

42. Unsatisfactory flow conditions were observed with all five tainter gates opened 2 ft and less with normal upper pool el 440.0. With discharges of 10,000 cfs and less, the depth of tailwater did not allow the flow to spread properly across the lower parabolic trajectory.

This resulted in unstable flow conditions involving concentrated jets and eddies in the stilling basin. These unstable flow conditions were present with tailwater elevations ranging from normal tailwater elevations to the minimum possible in the model due to flow control by the downstream channel.

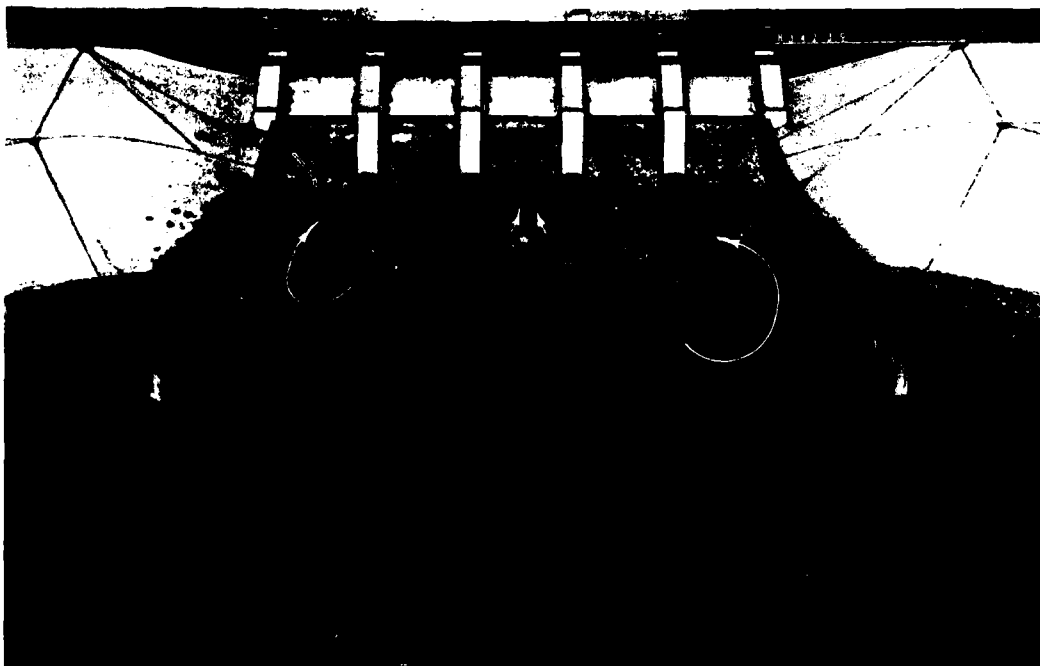
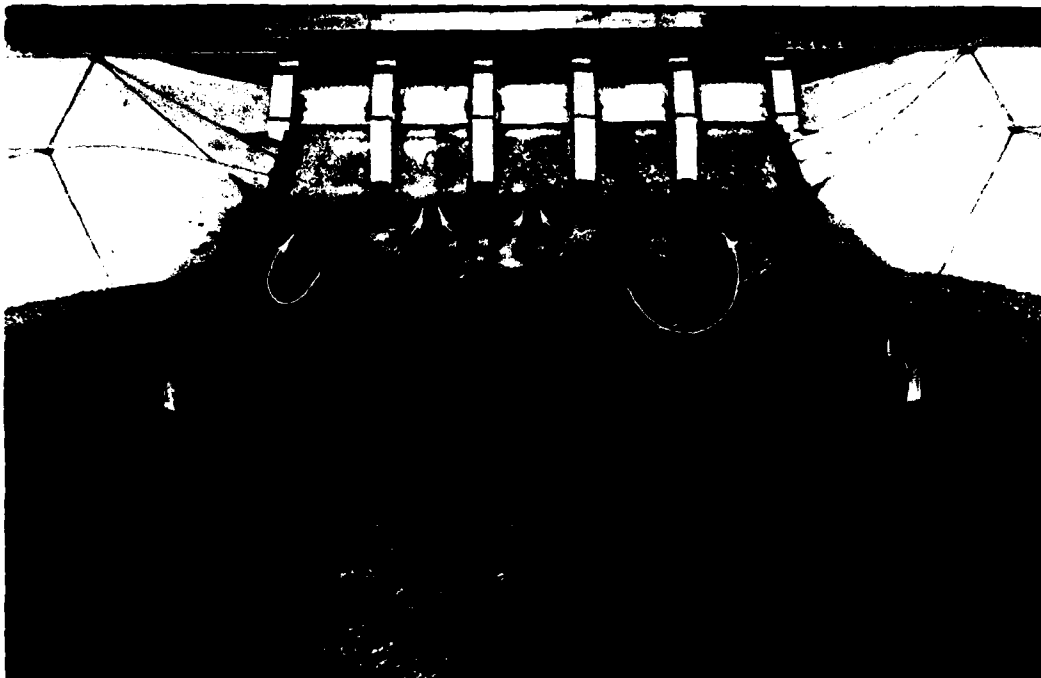
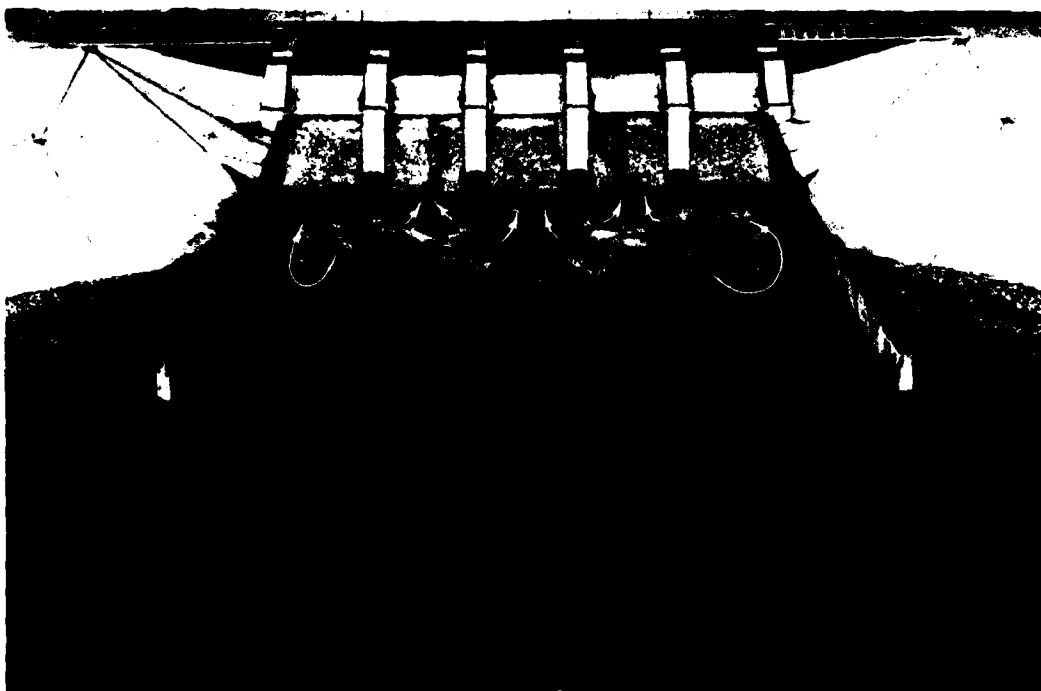
Photo 6. Looking upstream at flow conditions in the type 1 stilling
basin; discharges 1,500, 3,000, 4,500, and 6,000 cfs; upper pool
el 440.0 (Sheet 1 of 2)

a. Discharge passing through sluice D; discharge 1,500 cfs,
tailwater el 397.3

b. Discharge passing through sluices B and C; discharge 3,000 cfs,
tailwater el 398.0

c. Discharge passing through sluices B, C, and D;
discharge 4,500 cfs, tailwater el 398.5

d. Discharge passing through all sluices;
discharge 6,000 cfs, tailwater el 399.2

23. With normal tailwater depths, unsatisfactory flow conditions were observed for any and all combinations of sluice gate operations ranging from a single sluice gate to all sluice gates open (Photo 6). The unsatisfactory flow conditions resulted because the excessive tailwater depths concentrated the discharge from the sluices rather than spreading or distributing the flow properly across the lower parabolic trajectory. The unstable flow conditions created small intense eddies that could possibly move small rock and result in abrasive damage to the stilling basin. Although mild eddies occurred in the basin, satisfactory flow conditions were observed when tests were conducted with tailwater depths resulting from channel control. Tests results indicated that the maximum tailwater elevation for satisfactory flow conditions with sluice gate operations was approximately 394.0. Flow conditions with various sluice gate operations and a tailwater elevation of 394.0 are shown in Photo 7.

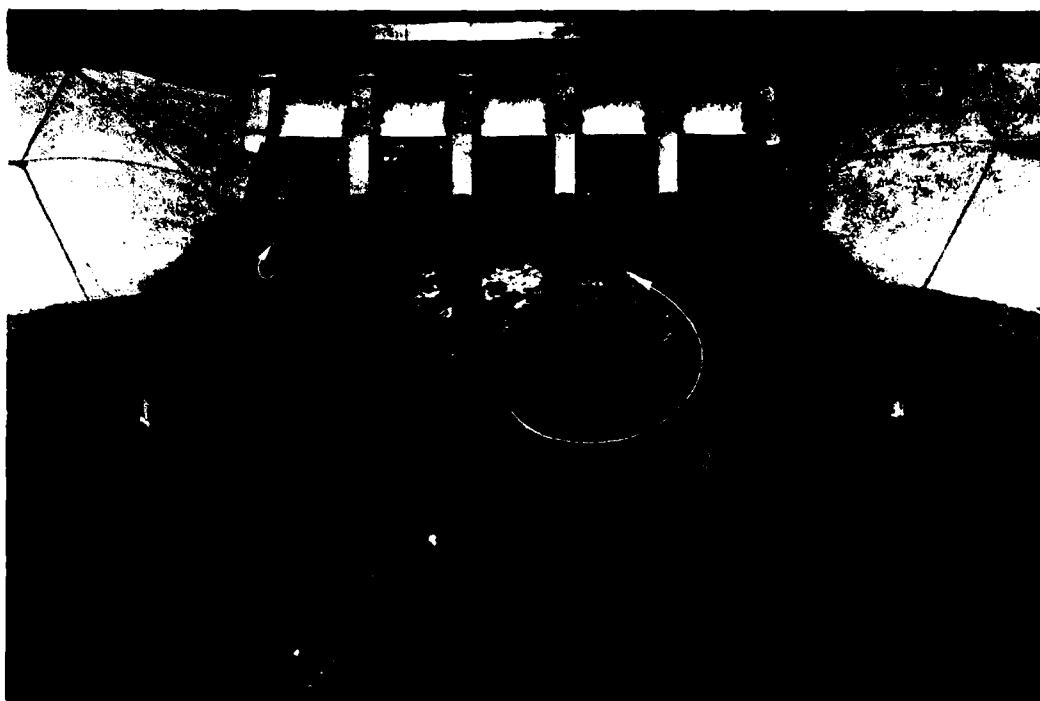
Photo 7. Looking upstream at flow conditions in the type 1 stilling basin; upper pool el 440.0, tailwater el 394.0 (Sheet 1 of 2)

a. Discharge passing through sluice D; discharge 1,500 cfs

b. Discharge passing through sluices B and C; discharge 3,000 cfs

c. Discharge passing through sluices B, C, and D; discharge 4,500 cfs

d. Discharge passing through all sluices; discharge 6,000 cfs

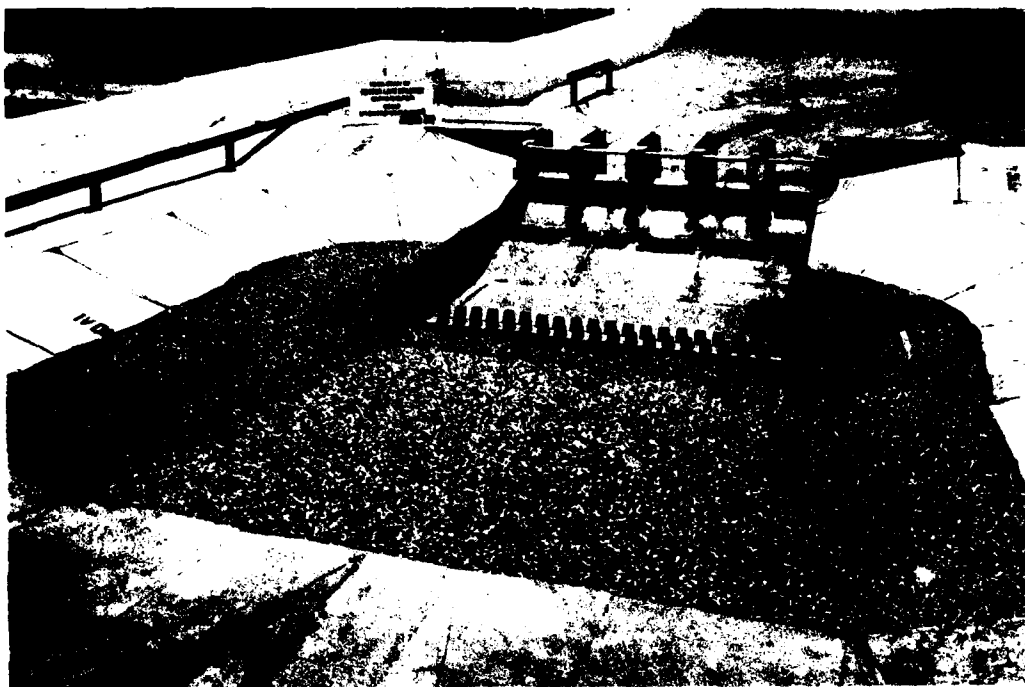
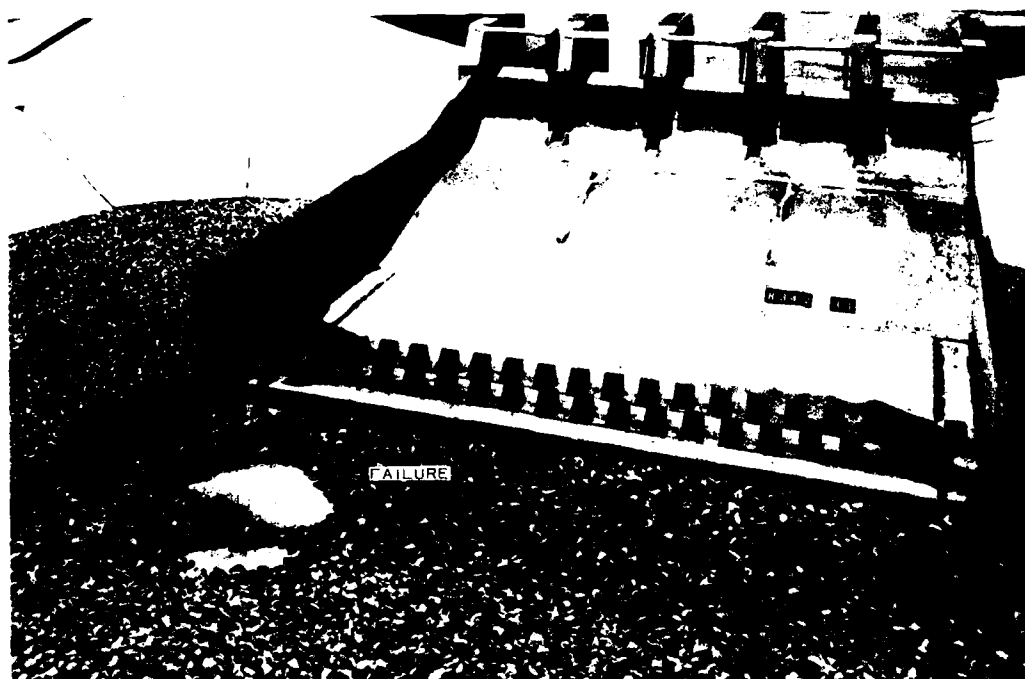
Photo 8. Type 2 riprap protection plan

a. Dry bed

b. Dry bed showing failure after a 36-hr (prototype) test with discharge 110,000 cfs, upper pool el 452.3, and tailwater el 410.5

30. In the type 2 riprap plan, 27-in. (D_{50}) stone was placed on the entire channel invert with a blanket thickness of 54 in. The riprap on the side slopes was increased to 18 in. (D_{50}) with a blanket thickness of 36 in. The riprap protection for the channel invert and the side slopes was extended from the stilling basin to 287 ft downstream (Photo 8). After a 36-hr (prototype) test with a discharge of 110,000 cfs, failure occurred just downstream of the end sill (Photo 8).

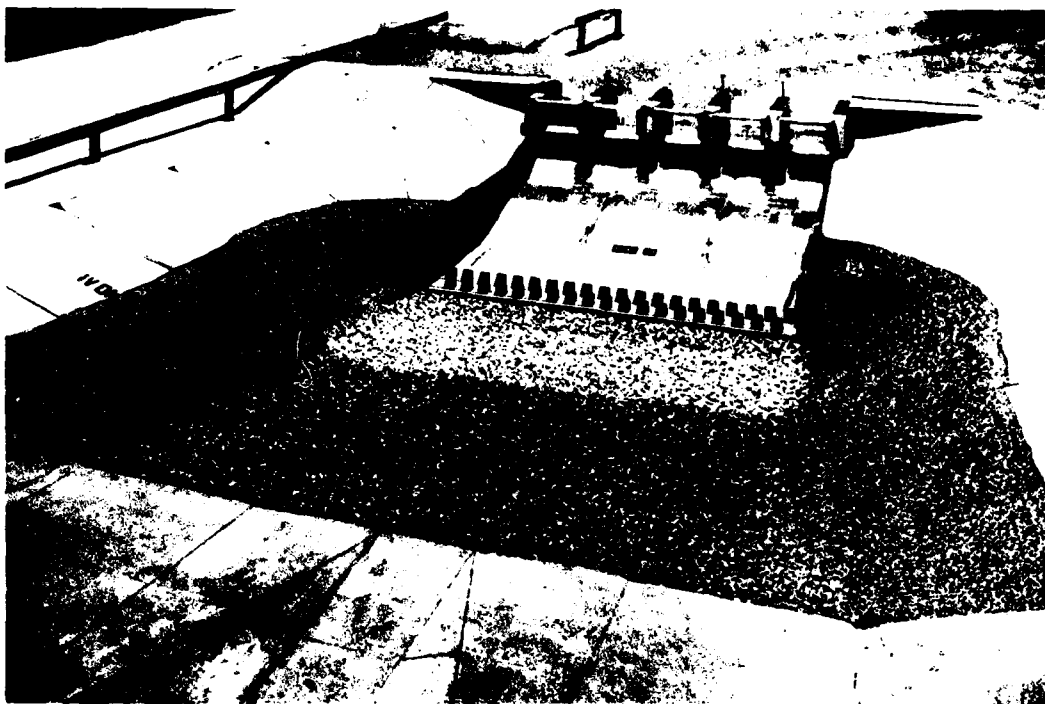
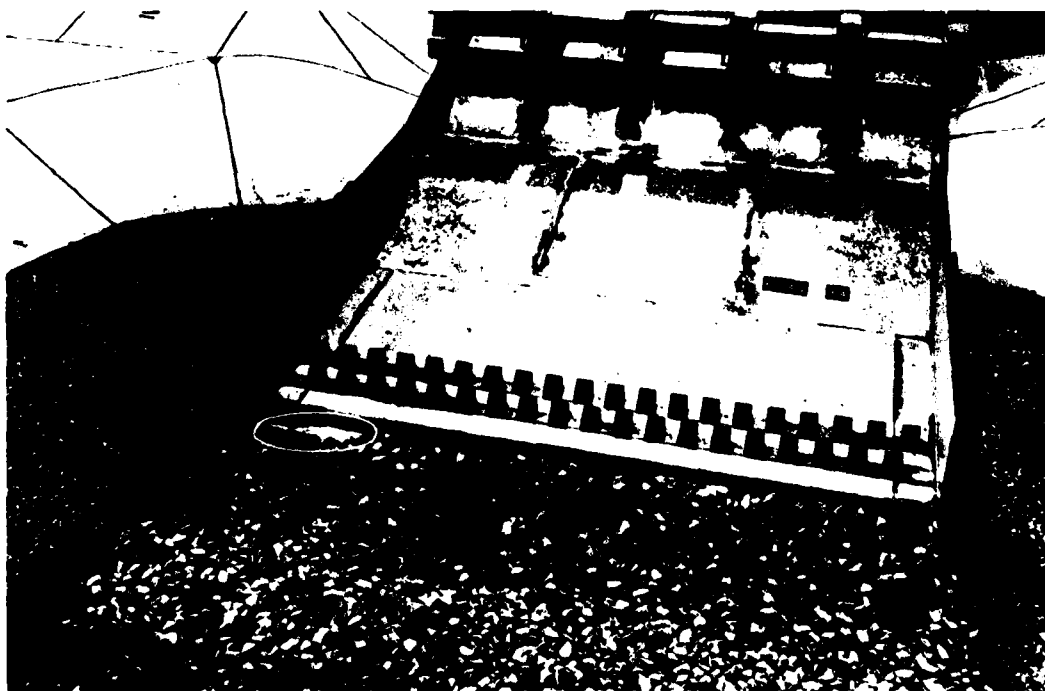
Photo 10. Type 4 riprap protection plan

a. Dry bed

b. Dry bed showing failure after a 48-hr (prototype) test with discharge 110,000 cfs, upper pool el 452.3, and tailwater el 410.5

32. The 32-in. (D_{50}) riprap was replaced with 36-in. (D_{50}) riprap with the 27-in. (D_{50}) and 18-in. (D_{50}) riprap protection covering the same areas as in the previous test (type 4, Photo 10). Again, failure was observed just downstream of the end sill after a 48-hr test with a discharge of 110,000 cfs (Photo 10).

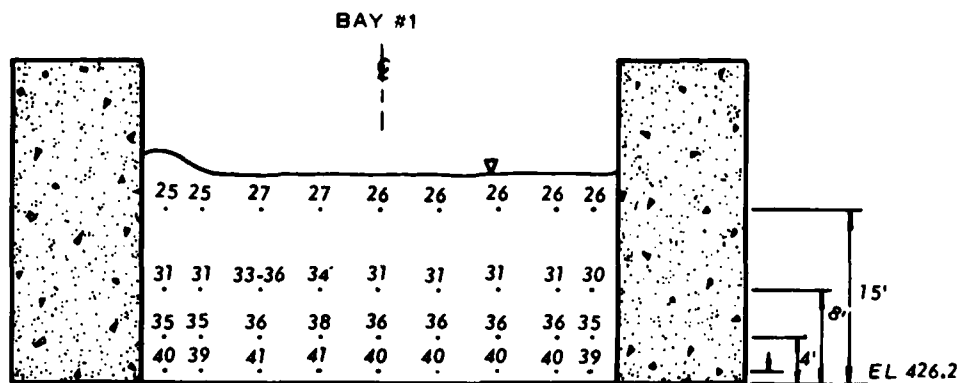
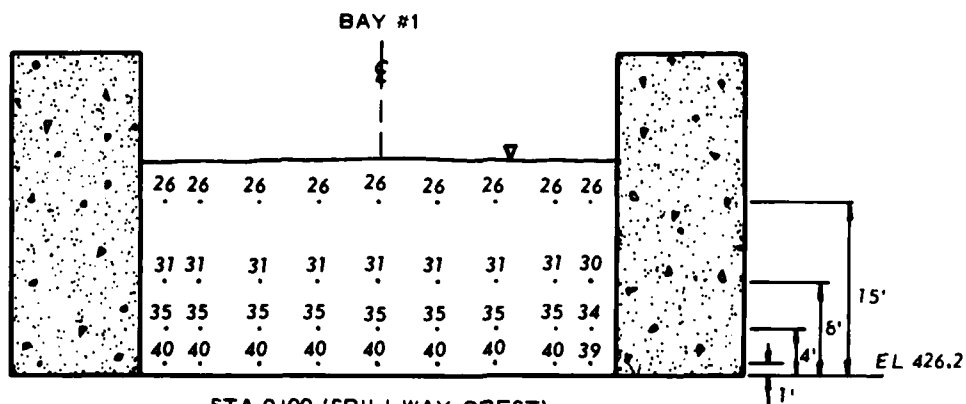
STA 0+00 (SPILLWAY CREST)
TYPE 2 APPROACH WING WALL

STA 0+00 (SPILLWAY CREST)
TYPE 3 APPROACH WING WALL

MAXIMUM VELOCITIES
TYPES 2 AND 3 APPROACH WING WALLS
DISCHARGE 110,000 CFS
UPPER POOL EL 452.2
TAILWATER EL 410.6

12. Several modifications to the approach wing walls upstream of the dam were tested in an attempt to reduce the buildup of the water surface along each side of the spillway and to further improve flow conditions throughout the structure. The type 2 design incorporated the original design wing walls and curved walls positioned on the 1V-on-3H slopes on each side of the spillway as shown in Plate 4. Test results showed that the type 2 design was not effective in reducing the buildup of flow along the walls. Velocities measured in the left bay (looking downstream) with the maximum discharge are shown in Plate 5.

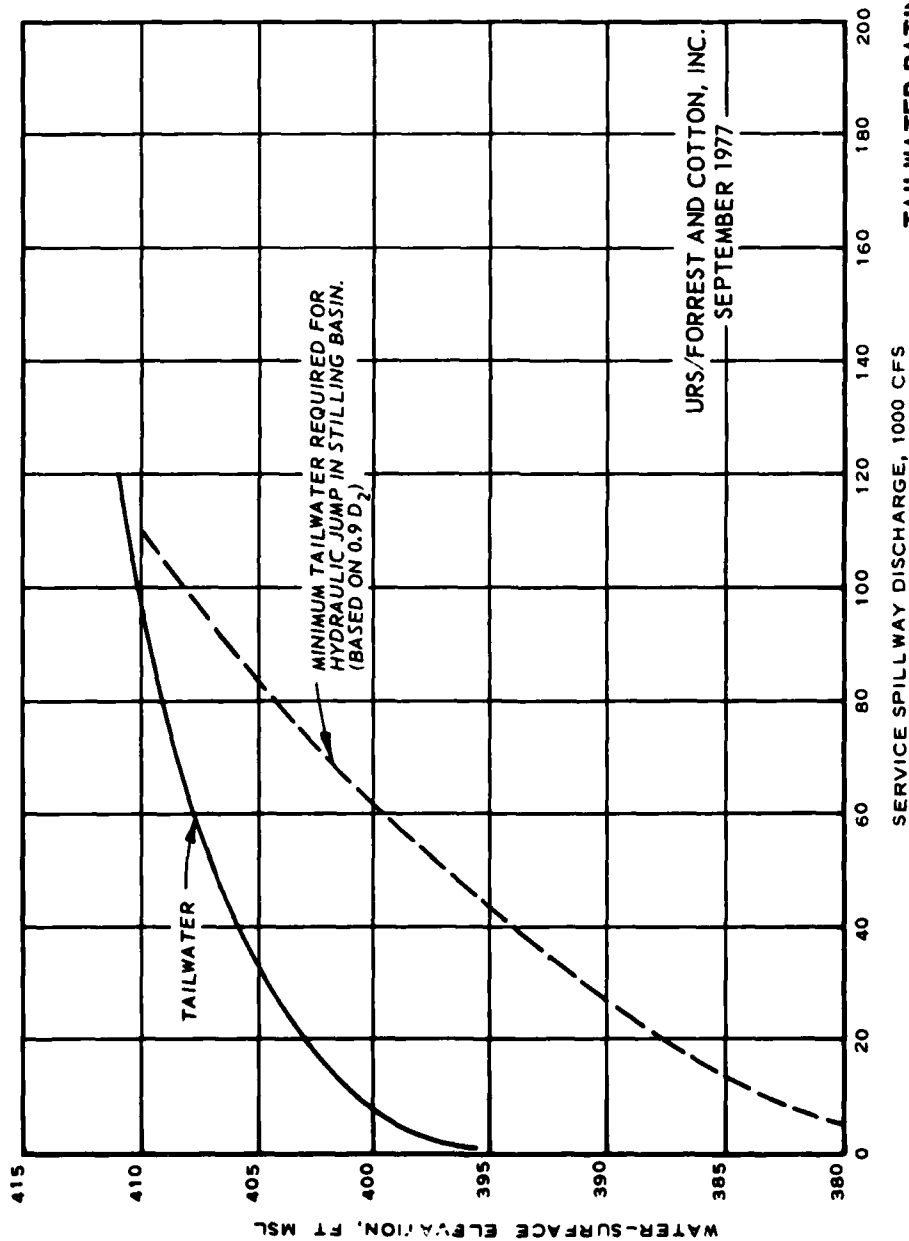
**TAILWATER RATING CURVE
AT SERVICE SPILLWAY STILLING BASIN**
1,000 TO 120,000 CFS

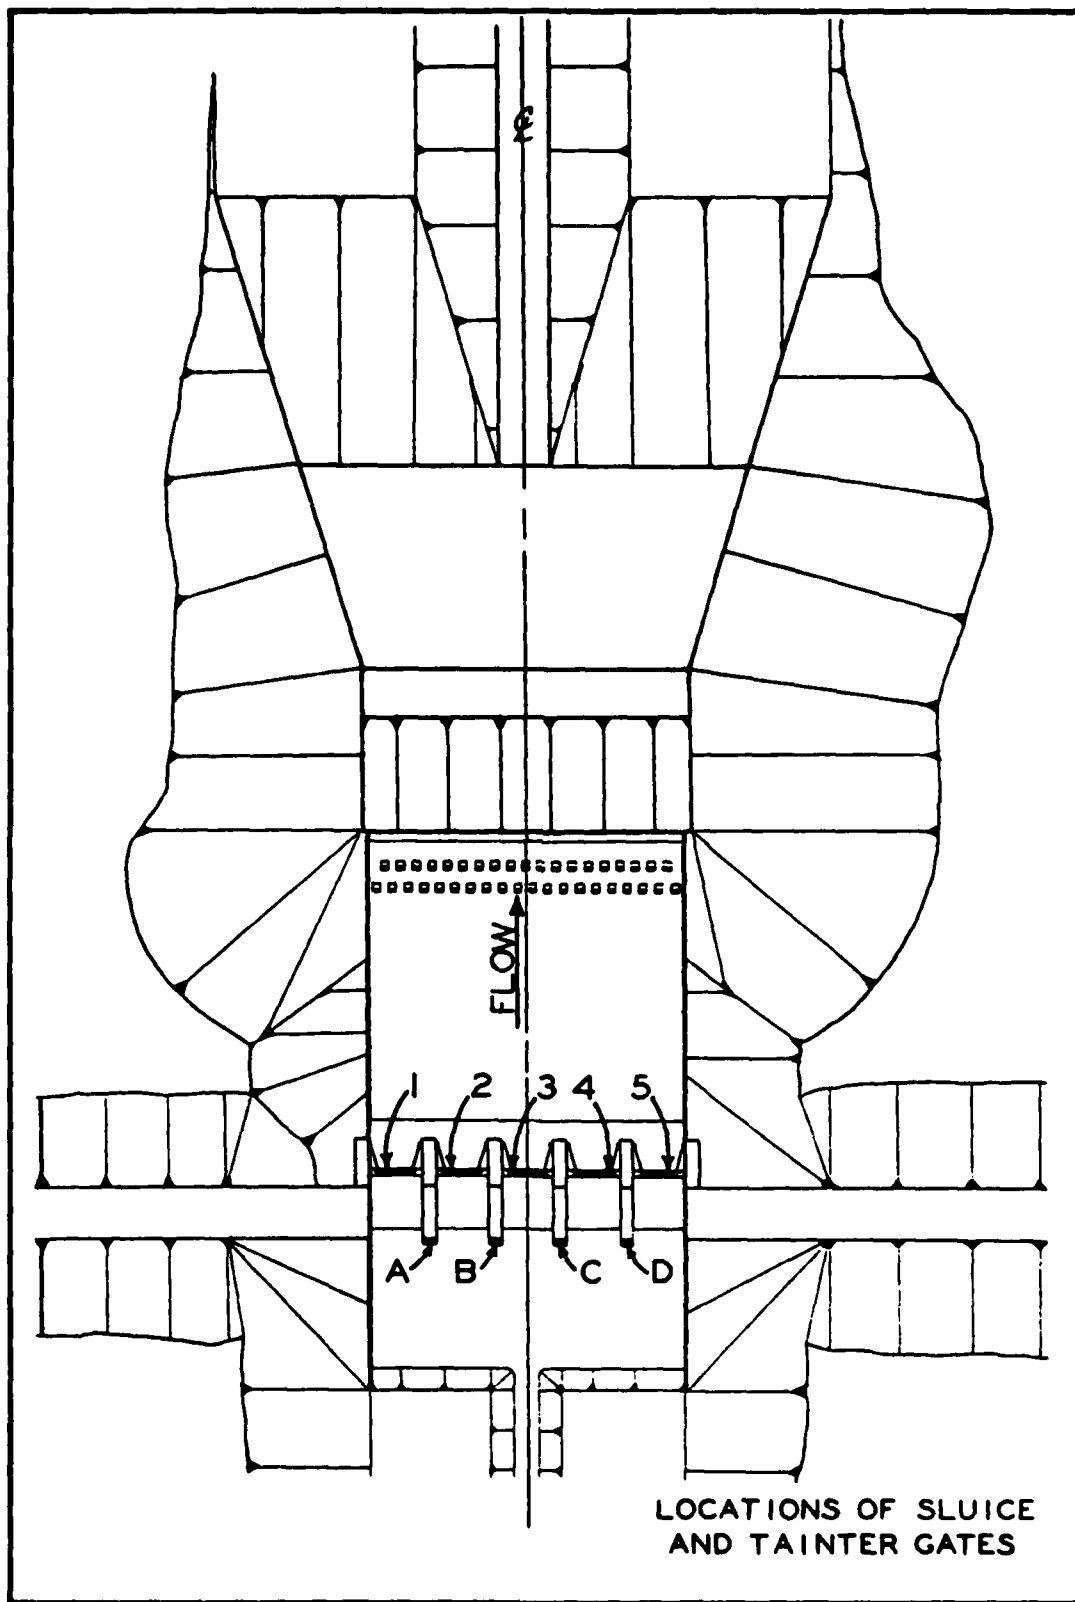
LOCATIONS OF SLUICE
AND TAINTER GATES

20. Flow conditions were observed with equal tainter gate operations for discharges ranging from 6,000 cfs to 16,500 cfs at normal upper pool. Satisfactory flow conditions were observed with all gates opened 3 ft and greater. However, unsatisfactory flow conditions occurred in the stilling basin with 1- and 2-ft gate openings. With the lower discharges, the depth of tailwater did not allow the flow to spread properly across the lower parabolic trajectory, which resulted in unstable flow conditions involving concentrated jets and eddies in the stilling basin as shown in Photo 5. These concentrated jets and eddies were present for all tests with tailwater elevations ranging from normal tailwater elevations (Plates 10 and 11) to the minimum possible in the model due to the flow control by the downstream channel (channel control depths, Plate 12). Tainter gate operations listed in Table 1 are gate arrangements producing the weakest eddies in the stilling basin. Combinations using four tainter gates were not listed since any four-gated arrangement produced small intense eddies that could possibly move rocks. The location and numbering system used to identify the tainter gates are shown in Plate 13.
